Maine Department of Transportation Transportation Research Division

Technical Report 02-3

*The Use of Micro-Surfacing for Pavement
Preservation*

Interim Report - Second, Third, Fourth Year; December, 2005

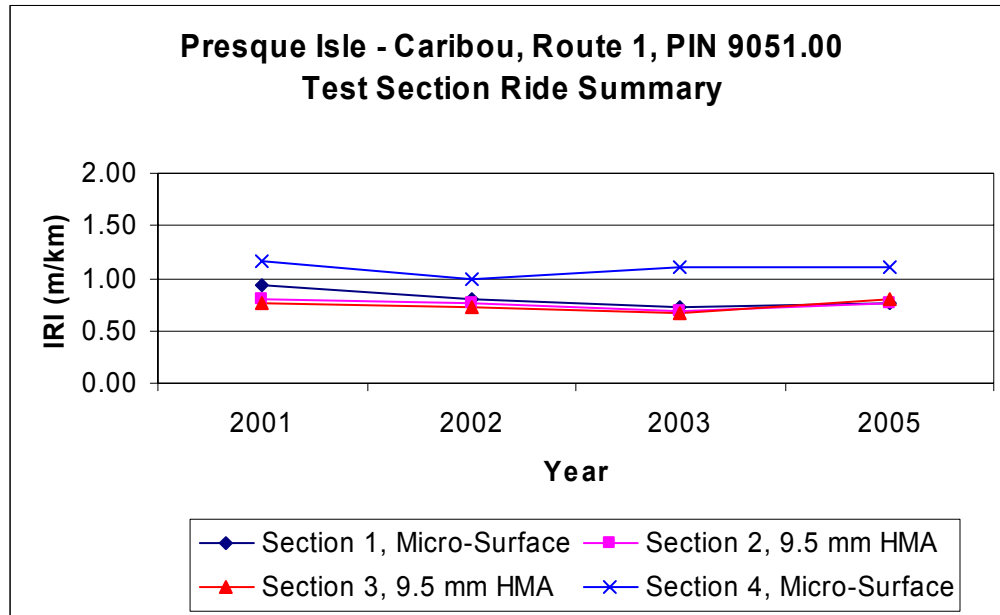
Figure 2: Presque Isle Test Section Level IRI Summary

Smoothness test results obtained from Sections 1, 2, 3, and 4 are displayed in Figure 2.

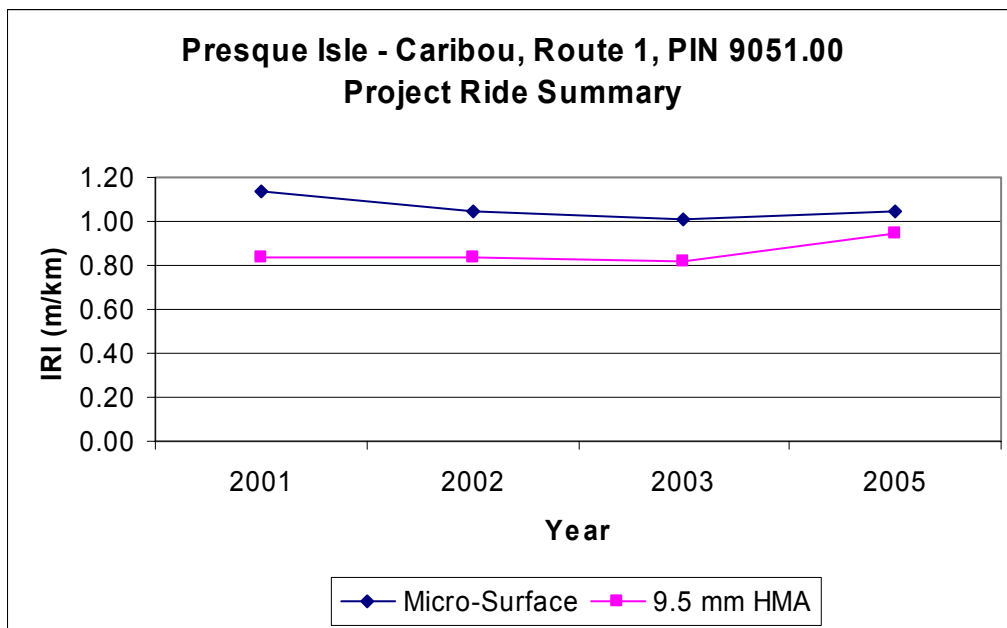
Figure 3: Presque Isle Project Level IRI Summary

For comparison the ARAN collected data on the entire length of the project. Figure 3 contains a summary of the test results.

Micro-Surfaced portions of the project have a slightly rougher ride than HMA. IRI values for Micro-Surface treatments decreased 0.03 m/km (1.9 in/mi) in 2003 to an IRI of 1.01 m/km (64.0 in/mi) then increased 0.04 m/km (2.5 in/mi) to an IRI of 1.05 m/km (66.5 in/mi) in 2005.

HMA treatments decreased 0.02 m/km (1.3 in/mi) in 2003 with an IRI of 0.82 m/km (52.0 in/mi) then increased 0.13 m/km (8.2 in/mi) in 2005 to an IRI of 0.95 m/km (60.2 in/mi).

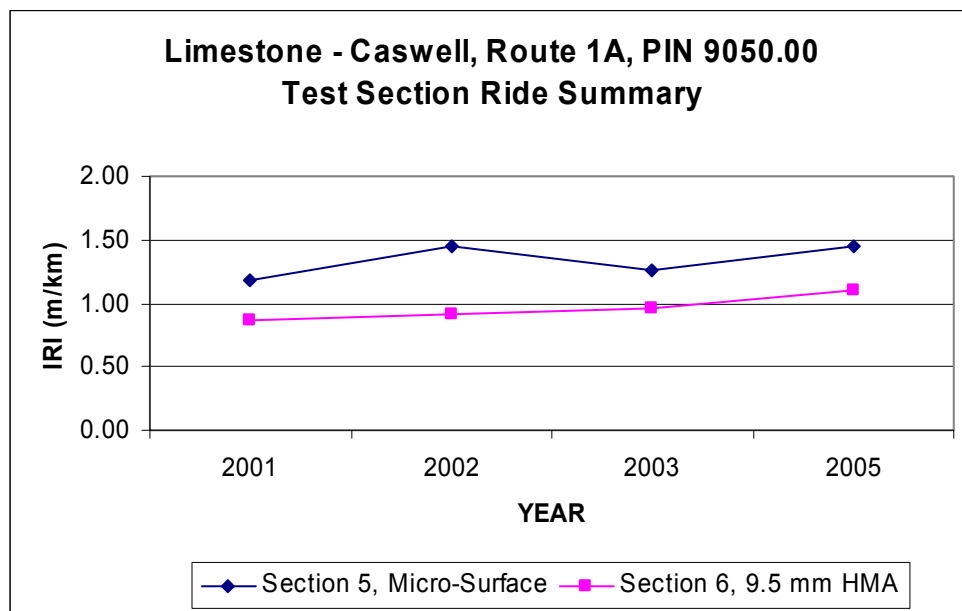
Figure 4: Limestone Test Section Level IRI Summary

Figure 4 contains smoothness test results for Section 5 and 6. Micro-Surfacing has higher IRI values than the HMA section.

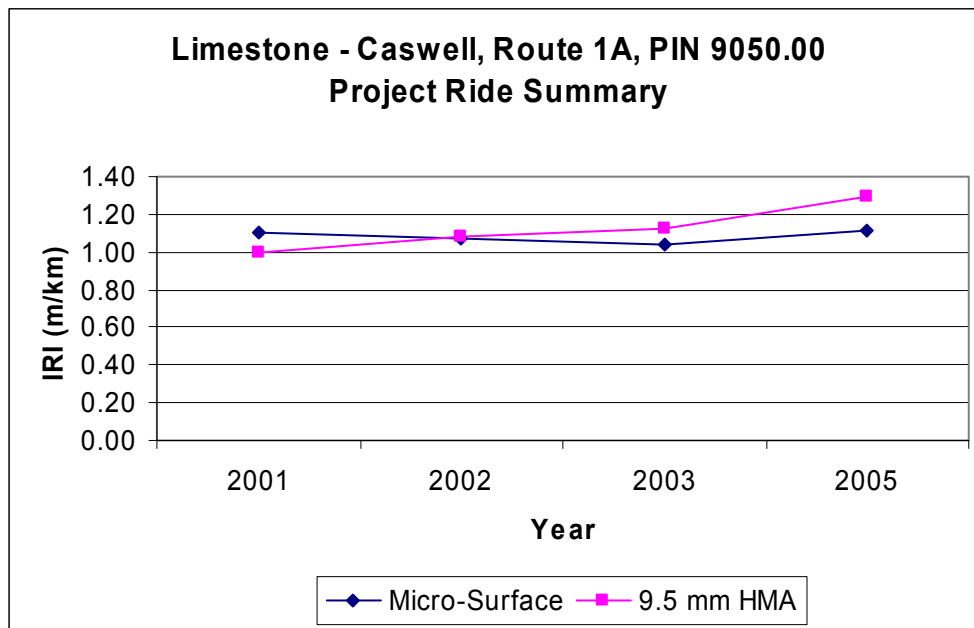
Figure 5: Limestone Project Level IRI Summary

The ARAN also collected data on the entire length of this project. Results are displayed in Figure 5.

IRI values have increased each year on the HMA portion of the project to a level that is rougher than the Micro-Surfaced portion. The ride increased 0.05 m/km (3.2 in/mi) in 2003 to an IRI of 1.13 m/km (71.6 in/mi) then increased an additional 0.17 m/km (10.8 in/mi) to an IRI of 1.30 m/km (82.4 in/mi) in 2005.

All IRI values remain in the smooth range of 1.02 – 1.57 m/km (65-99 in/mi).

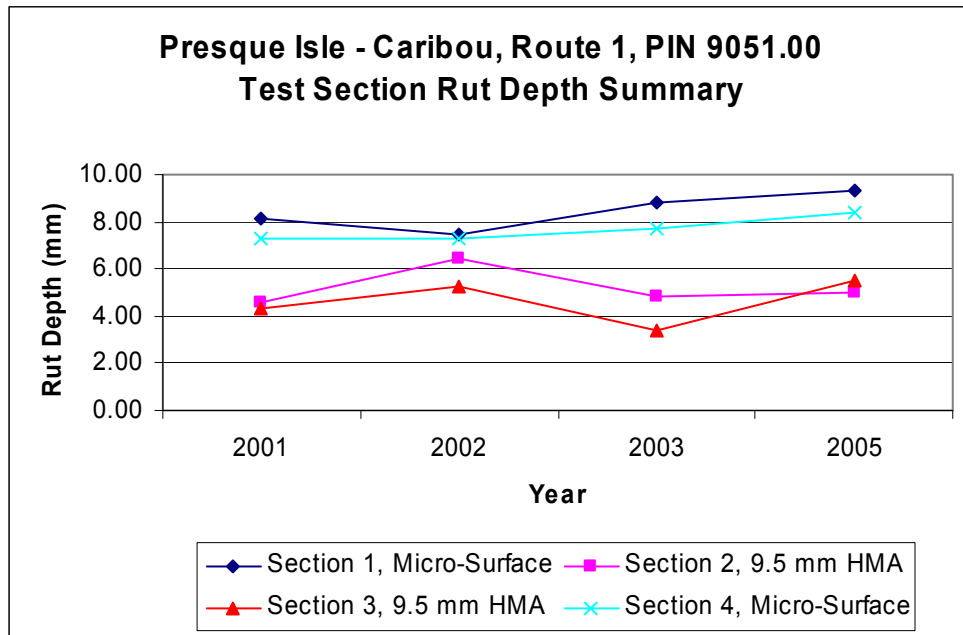
Figure 6: Presque Isle Test Section Level Rut Depth Summary

HMA rutting continues to be less severe than Micro-Surfaced areas. Figure 6 contains a summary of rut depth measurements for each test section.

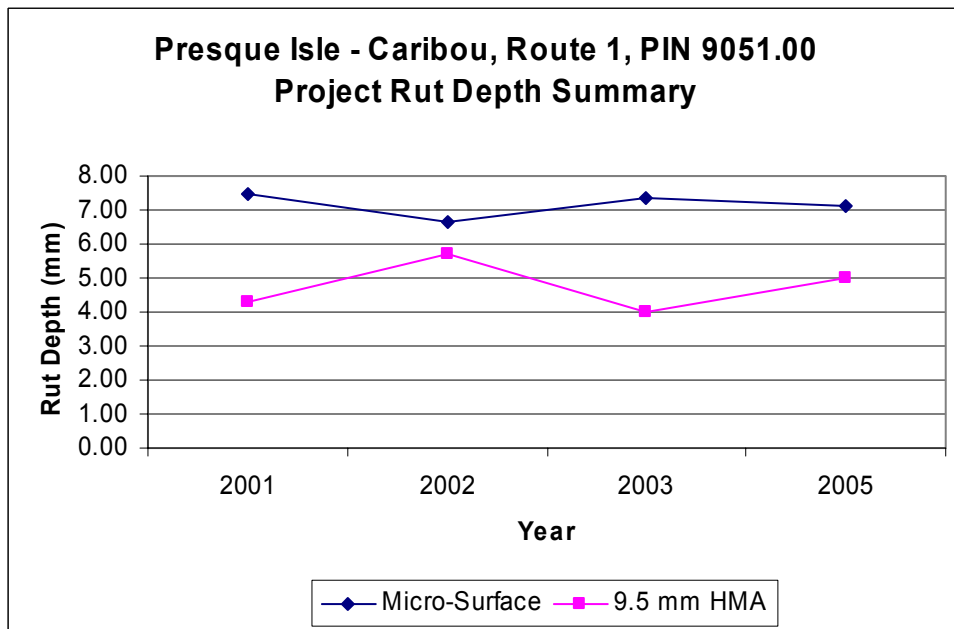
Figure 7: Presque Isle Project Level Rut Depth Summary

Figure 7 contains a summary of rut depth measurements collected on the length of the project. Micro-Surface portions increased 0.7 mm (0.03 in) in 2003 to a depth of 7.4 mm (0.29 in) then decreased 0.2 mm (0.01 in) to a depth of 7.1 mm (0.28 in) in 2005.

HMA portions decreased 1.7 mm (0.07 in) to a depth of 4.0 mm (0.16 in) in 2003 then increased 1.0 mm (0.04 in) to a depth of 5.0 mm (0.20 in) in 2005.

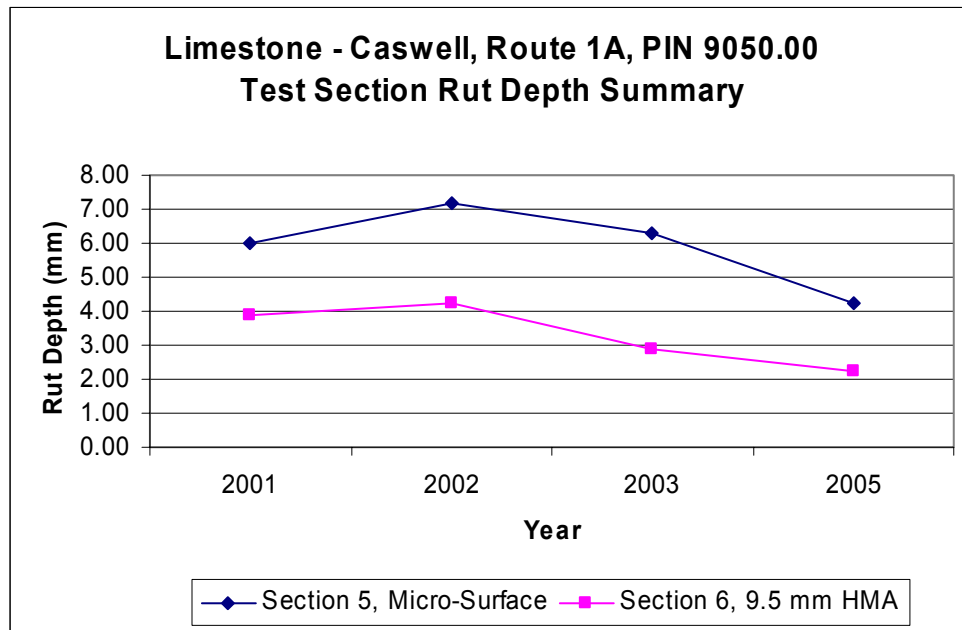
Figure 8: Limestone Test Section Level Rut Depth Summary

Rutting decreased on both sections in 2003 and 2005. Figure 8 contains a Rut Depth Summary of the test sections. Micro-Surface Section 5 decreased 12.2 % from 7.2 mm (0.28 in) to 6.3 mm (0.25 in) in 2003. Rutting decreased an additional 32.3 % in 2005 to a depth of 4.3 mm (0.17 in).

The decrease in rut depths could be attributed to the amount of plow wear on Micro-Surfaced sections, detailed in the Visual Inspection portion of the report, and heavy loads riding on centerline depressing centerline and between wheel path areas of Level 2 sections smoothing out the roadway profile.

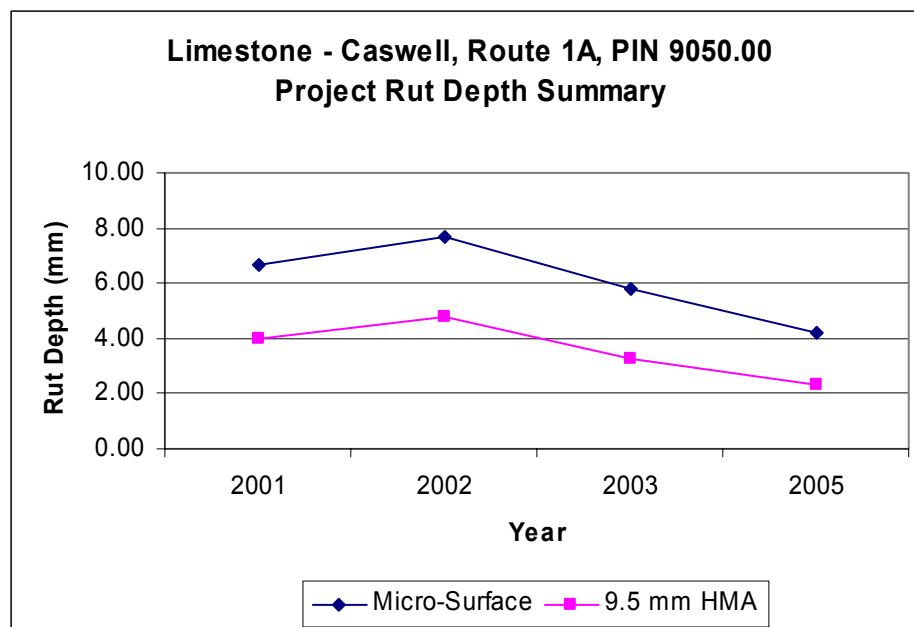
Figure 9: Limestone Project Level Rut Depth Summary

Average rut depths for the project also decreased in 2003 and 2005. Figure 9 displays a summary of the results. Micro-Surface treated portions of the project decreased 24.4 % from 7.7 mm (0.30 in) in 2002 to 5.8 mm (0.23 in) in 2003. Rutting decreased an additional 27.1 % to a depth of 4.2 mm (0.17 in) in 2005.

HMA portions of the project decreased 31.4 % from 4.8 mm (0.19 in) in 2002 to 3.4 mm (0.13 in) in 2003 then an additional decrease of 30.2 % to a depth of 2.3 mm (0.09 in) in 2005.

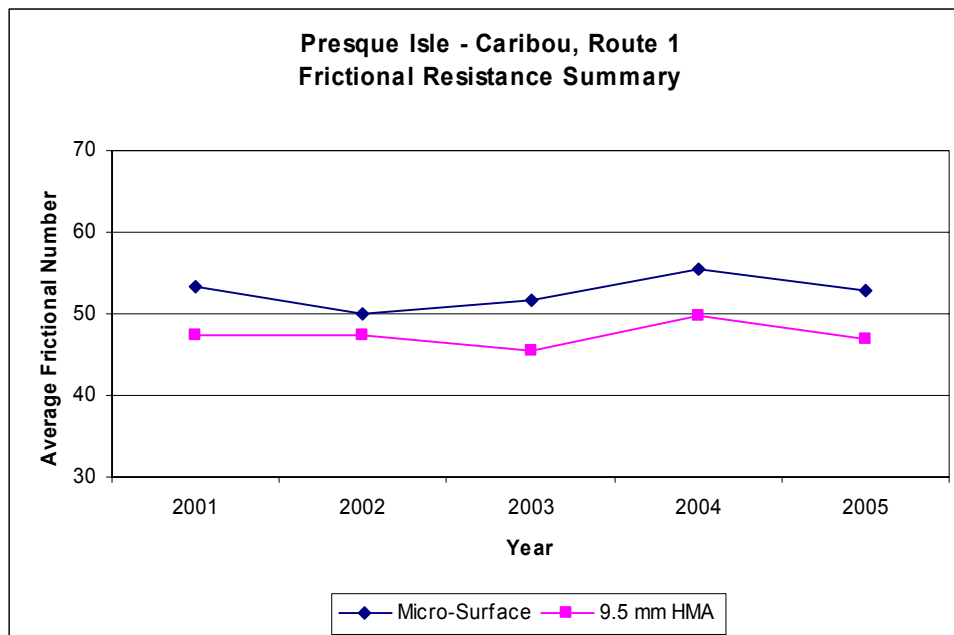
Figure 10: Presque Isle Frictional Resistance Summary

Figure 10 contains a summary of Frictional Numbers (FN) for the Presque Isle project. Frictional resistance increased from a FN of 49.9 in 2002 to 51.7 and 55.5 in 2003 and 2004. Frictional resistance decreased 4.86 % in 2005 to a FN of 52.8.

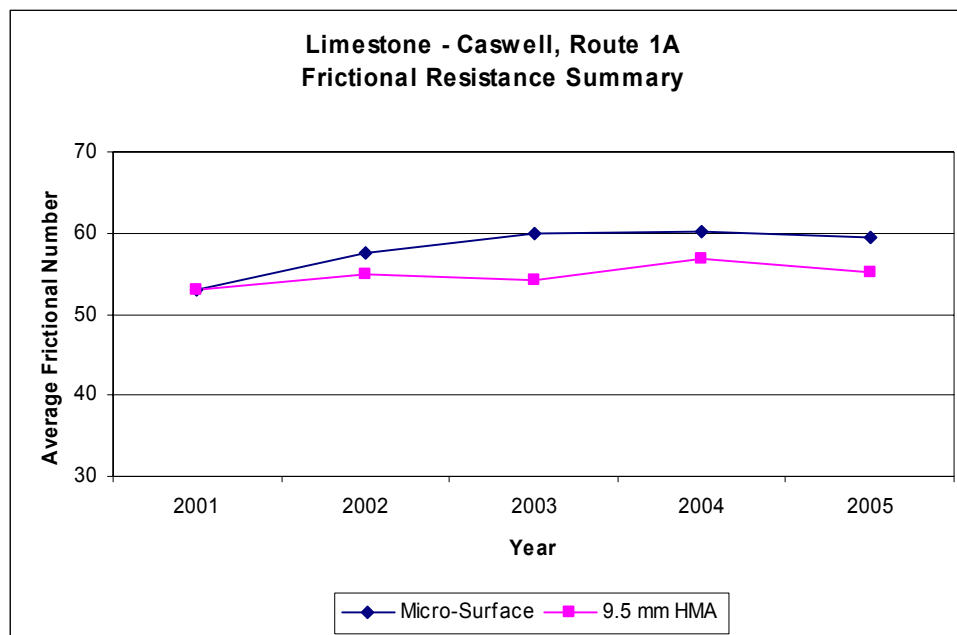
Figure 11: Limestone Frictional Resistance Summary

Figure 11 displays a summary of Frictional Numbers for the Limestone project. Micro-Surfaced portion increased in 2003 and 2004 to a FN of 59.9 and 60.3 respectively. Frictional resistance decreased 1.3 % to a FN of 59.4.

HMA Frictional Numbers decreased slightly from 54.8 to 54.3 in 2003 then increased 4.4 % to a FN of 56.8 in 2004. In 2005 there was another small decrease of 3.0 % to a FN of 55.1.
